# Characterizing PCB contamination in Painted Concrete and Substrates: The “Painted History” at Army Industrial Sites

ERDC-EL Environmental Engineering

- **July 2008** –Collected paint and substrate samples of 3 inactive non-explosive building lines slated for demolition, in order to determine if the buildings contained PCBs

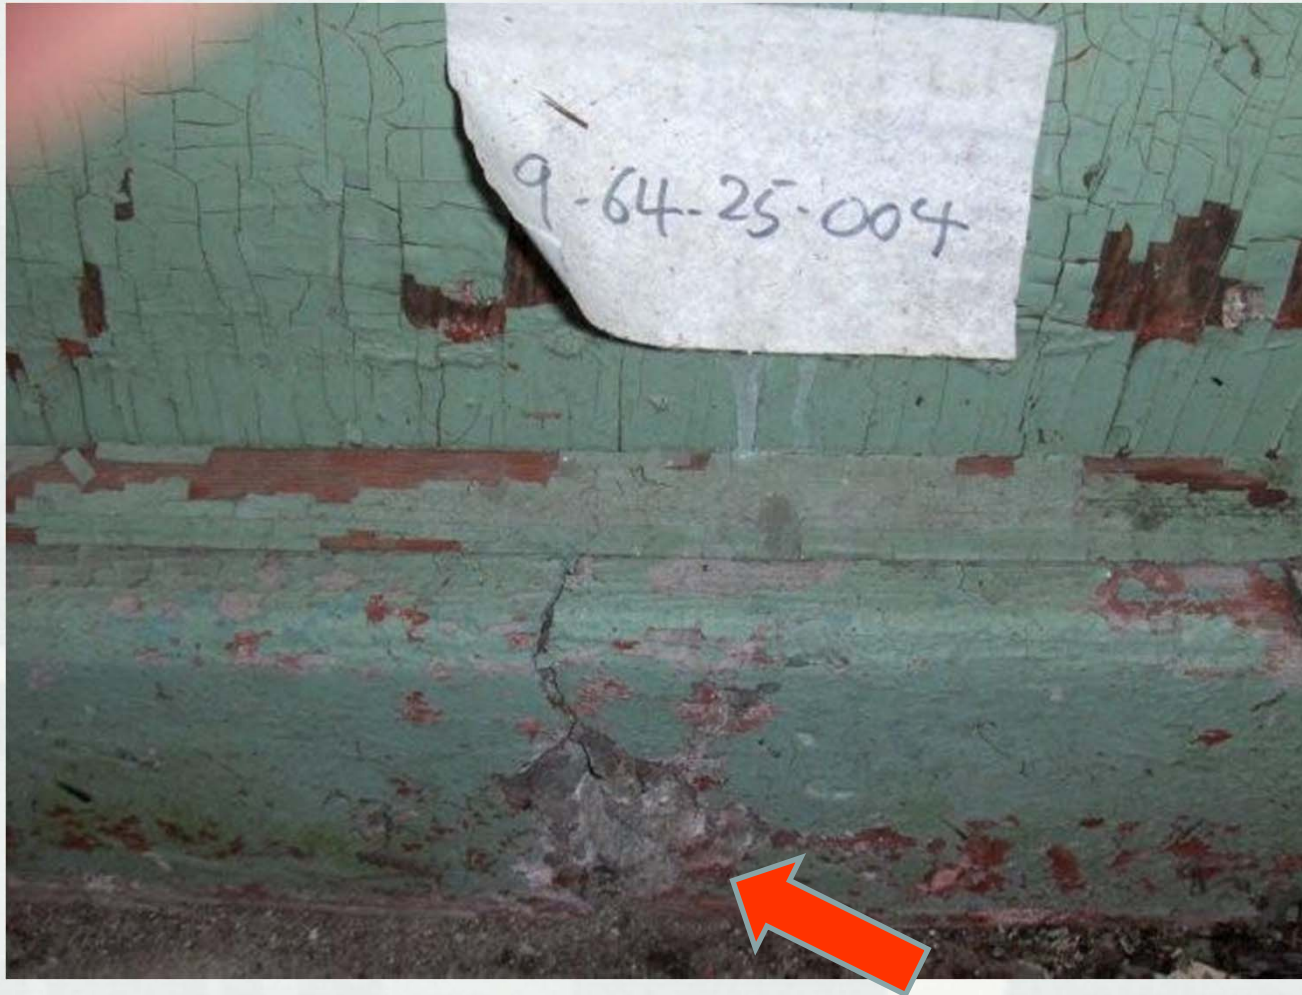
# 2009 Composites Samples Not Representative

- The 2008 and 2009 concrete samples were not representative of the waste stream.
- The 2009 composite sampling report states that 1 inch in diameter by  $\frac{1}{2}$  to  $\frac{3}{4}$  inch deep core samples were collected. However, some of these building materials were over 1 foot thick.
- A site visit was conducted to assess the 2008 sampling locations and it was discovered that the substrate samples had only the first couple of milliliters of material collected, apparently by hammer and chisel.

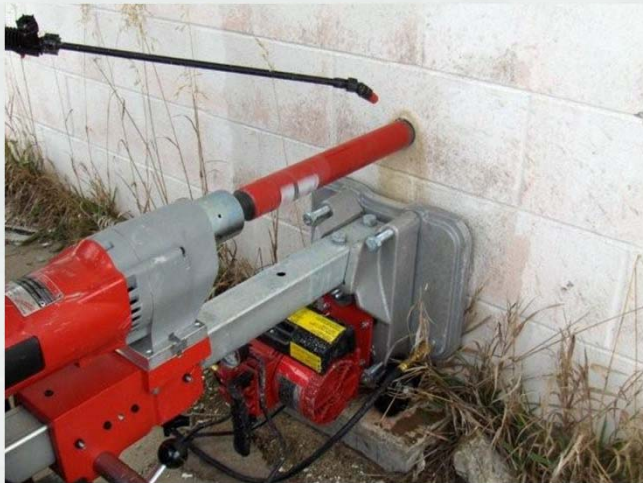
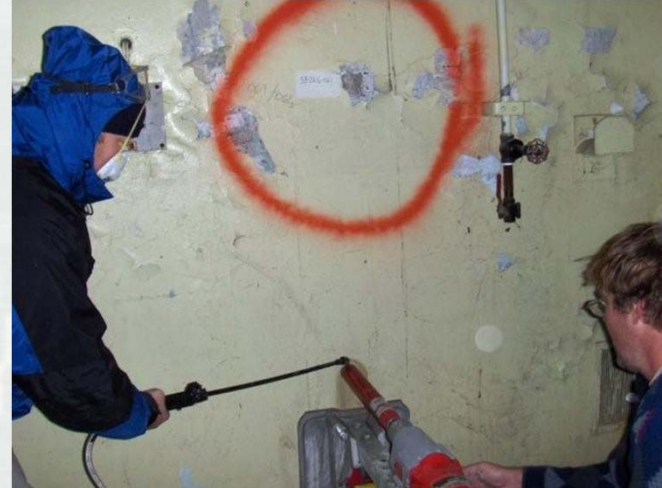
- A case study at Iowa Army Ammunition Plant IAAAP was performed with the “Paint Histories” in which the walls of industrial concrete and porous building materials were sampled and analyzed for PCB contamination
- **November 2010** ERDC re-sampled the buildings using a coring machine, as opposed to previous sampling efforts that used hand tools. The 2008 and 2009 concrete samples were not representative of the waste stream.

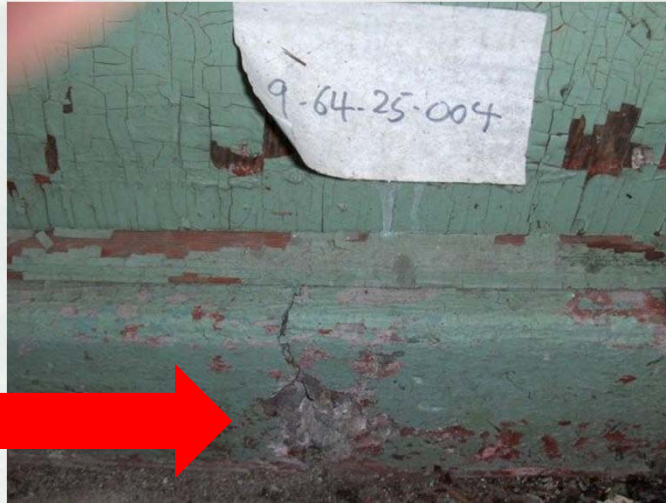
The 2009 composite sampling report states that 1 inch in diameter by  $\frac{1}{2}$  to  $\frac{3}{4}$  inch deep core samples were collected.

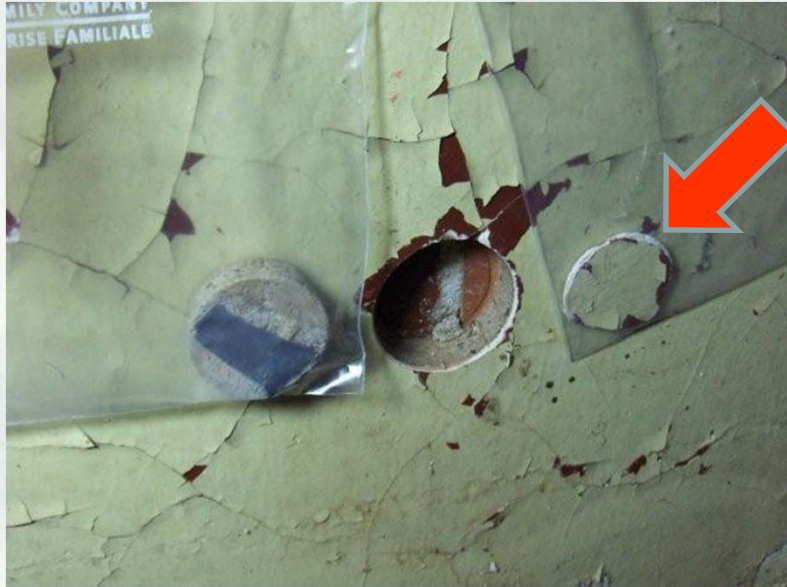
Where surface paint concentrations of 290 mg/kg were observed, only 2 mg/Kg was present in the plaster directly beneath the paint.

gradients in concentration with depth were not observed in the data
